Preliminary Investigation of a Non-Condensation Area in Need of Redevelopment Stop & Shop Site and Adjacent Commercial Properties

Block 3002, Lots 1, 2, 3, 4, 5, 6, 7, 8, 30, 34, 35, 36 & 37

Borough of Highland Park, Middlesex County, New Jersey

Prepared by **LRK, Inc.** | November 23, 2022

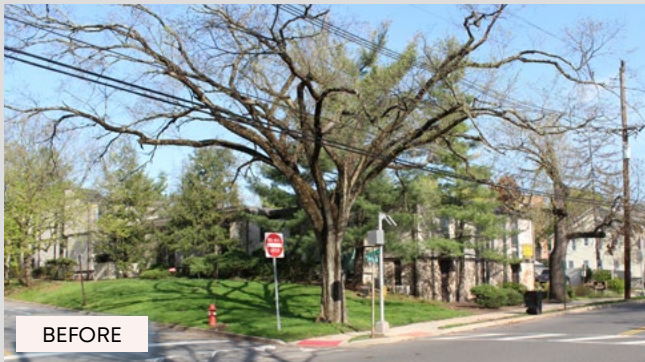
31 River Road

The Redevelopment Area is located in the western portion of the Borough, and is directly opposite the Environmental Education Center and the Raritan River Greenway. The one-acre lot contained a one-story medical office building containing approximately 11,000 SF of floor area, which stood isolated within a primarily residential area.

The plan promoted multi-family housing in order to attract new markets like empty-nesters and millennials to the community. The Borough incorporated neighborhood input into the plan, including goals and objectives that maintained the existing rear parking lot and vegetation as well as improved existing pedestrian and bicycling issues.

The ultimate redevelopment, now known as "The Frederick," was completed with 34 market-rate and six (6) affordable units.

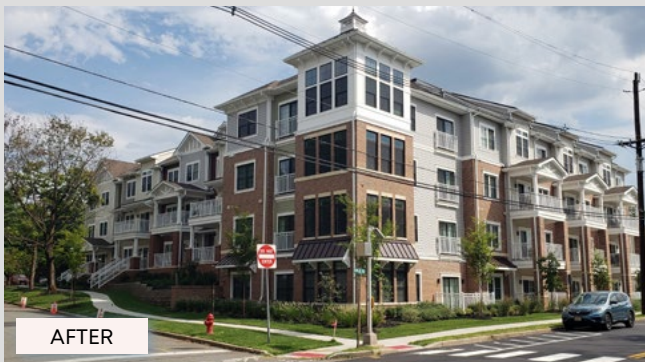
137-139 Raritan Avenue

A small one-story commercial building with limited parking facilities originally stood at 137-139 Raritan Ave. The 2005 Downtown Redevelopment Plan was amended in 2017 to permit residential uses on the ground floor at the rear of the building, providing for needed accessible and affordable housing.

The plan also permitted off-site parking (set at one (1) parking space within 1,000 feet of the property for each residential unit and prohibiting curb cuts along Raritan Avenue), which allowed for the project to move forward after delays.

The redevelopment project culminated in a mixed-use building that expanded the first floor and added a second story to accommodate 2,860 SF of commercial space, four (4) market-rate units and one (1) affordable unit.

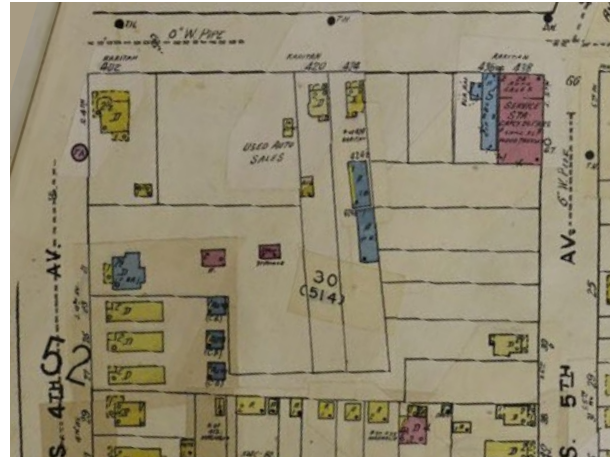
1936 Sanborn Map

The 1936 Sanborn map to the right depicts multiple frame dwellings (in yellow) with one-story porches and small detached garages, a large used auto sales lot, a one-story cinder block building (in blue), and a one-story brick building (in red) which was utilized for auto sales and service.

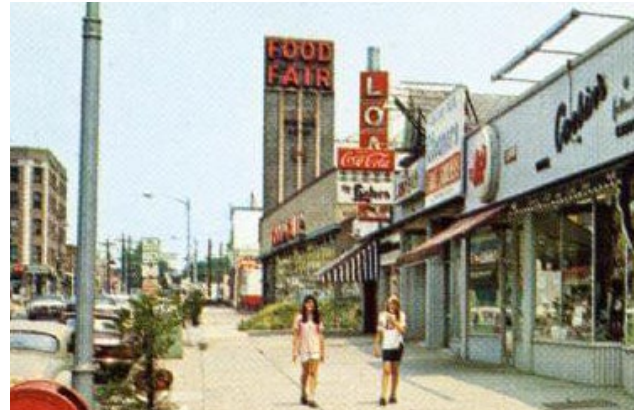
Photo of Food Fair Building

Between 1969 and 1971, the Food Fair building was demolished and permits were issued for the construction of a larger one-story, approximately 26,000 square foot grocery store situated at the extreme rear of the property and a large exposed surface parking area at the front of the property along Raritan Avenue. Initially opened as Pantry Pride, the grocery store was acquired and/or re-branded as Food Town, Edwards Super Food Store and, finally, Stop & Shop.

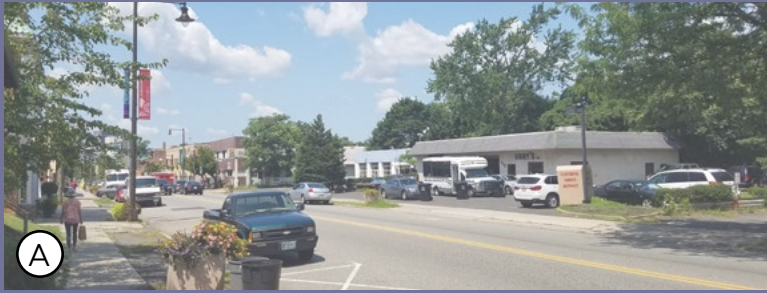
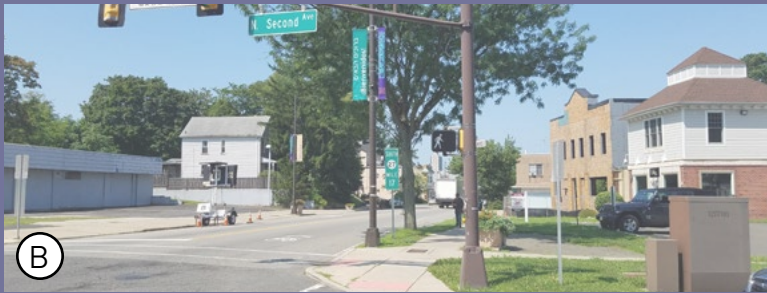
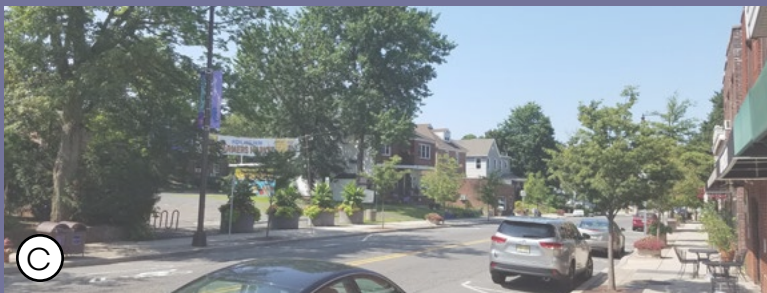
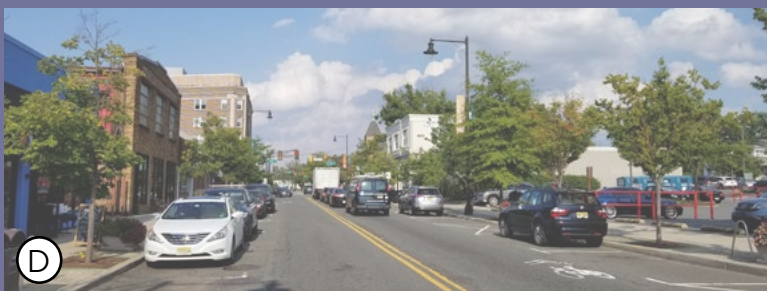
RARITAN AVENUE EXISTING CONDITIONS

Existing conditions along Raritan Avenue in the **downtown area** include numerous “gaps” in the streetscape created by vacant properties and exposed parking lots.

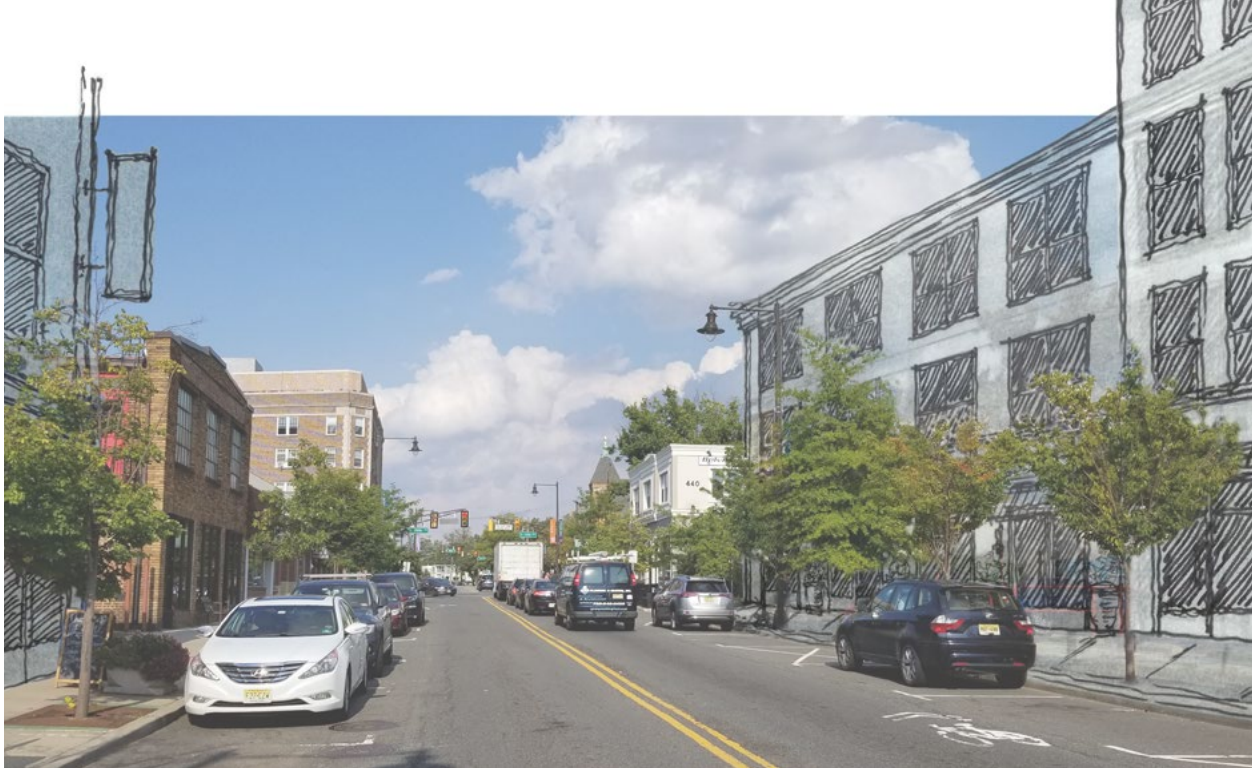
From the Land Use Plan Element of the Master Plan, the above sketch depicts the possibility of infill development to fill in the gap in the street frontage.

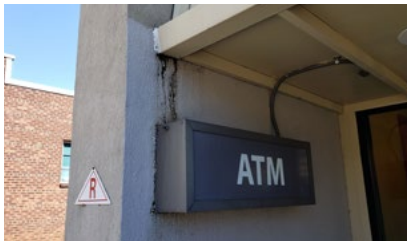
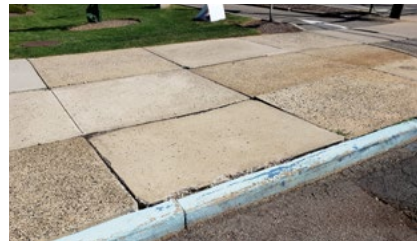
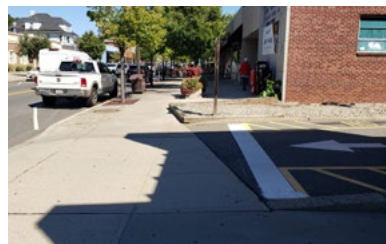
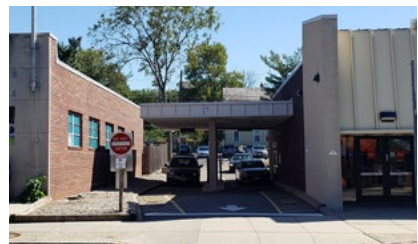
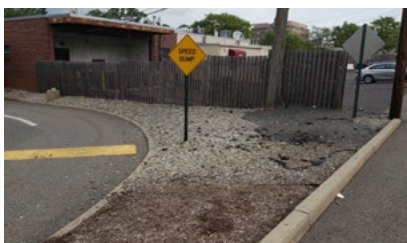
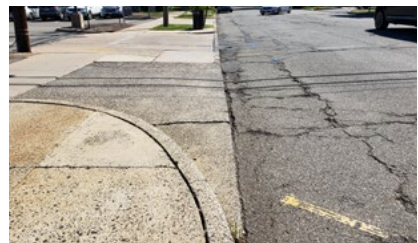
Representative Photos

Block 3002, Lot 1 is a rectangular-shaped corner lot with 95 feet of frontage along the south side of Raritan Avenue, 150 feet of frontage along the east side of South 4th Avenue, 95 feet of frontage along the north side of the stub public right-of-way, and is approximately 14,250 square feet (0.3280 acres) in area. The property conforms to the bulk requirements of the zoning ordinance; however, the building is non-conforming with the minimum height requirement, and potentially other ordinance standards.

Due to a combination of the dilapidated conditions, faulty arrangement or design and/or obsolete layout of various improvements, the property is detrimental to the safety, health, morals and welfare of the community in accordance with **Criterion D** of the LRHL.

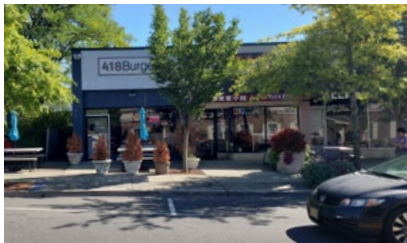
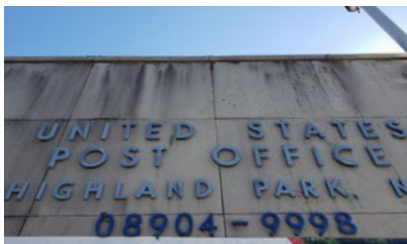
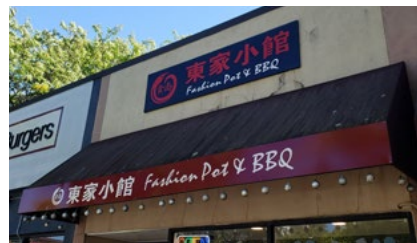
Representative Photos

Block 3002, Lot 2 is an irregularly-shaped mid-block through lot with 143.35 feet of frontage along the south side of Raritan Avenue, partial frontage on the north side of the stub public right-of-way, a depth of approximately 150 feet, and is approximately 23,237 square feet (0.5105 acres) in area. The property conforms to the bulk requirements of the zoning ordinance; however, the building is non-conforming with the minimum height and impervious coverage requirements, and potentially other ordinance standards.

These conditions may result in driver confusion and contribute to a circulation pattern that is unsafe for motorists, bicyclists and pedestrians.

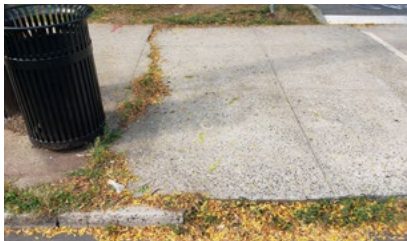
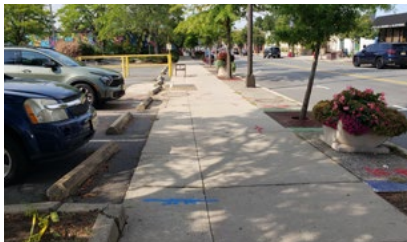
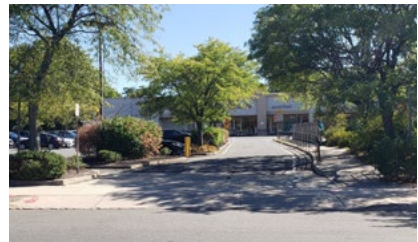
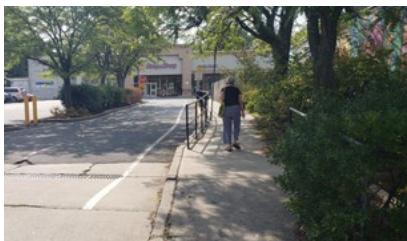
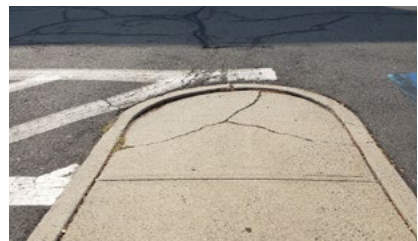
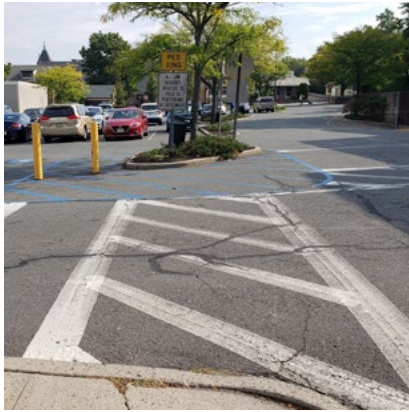
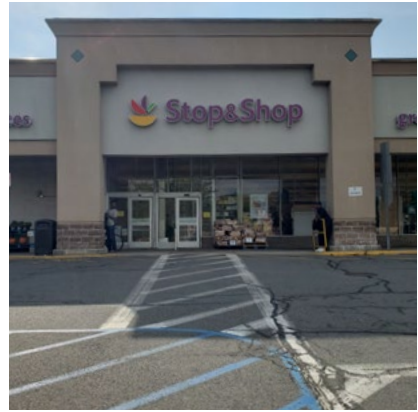
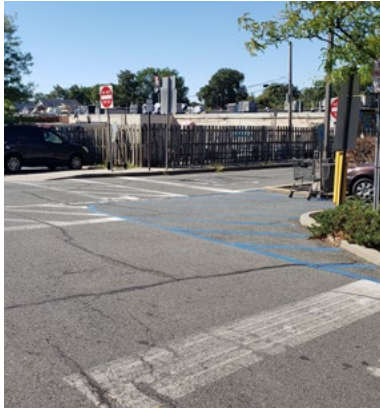
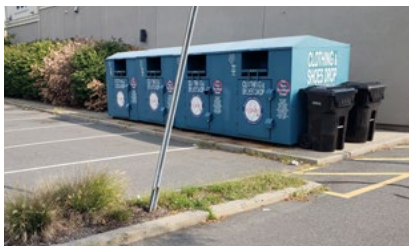
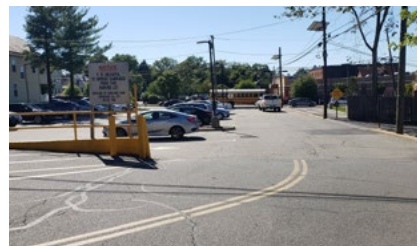
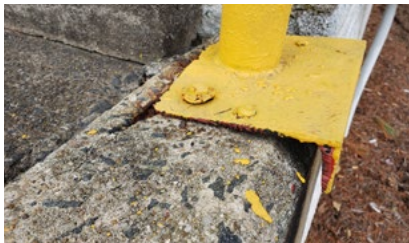
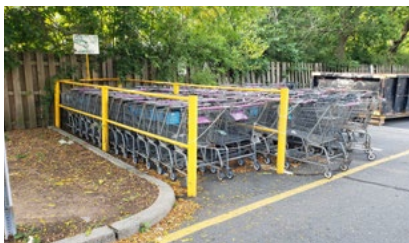
Representative Photos

Block 3002, Lot 2 is an irregularly-shaped corner lot with 234.92 feet of frontage along the south side of Raritan Avenue, 167.85 feet of frontage along the west side of South 5th Avenue, and is approximately 99,320 square feet (2.2802 acres) in area. The property conforms to the bulk requirements of the zoning ordinance; however the building is non-conforming with the minimum height and rear yard setback requirements, and potentially other ordinance standards.

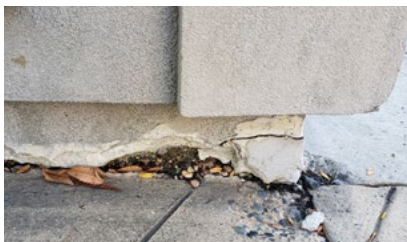
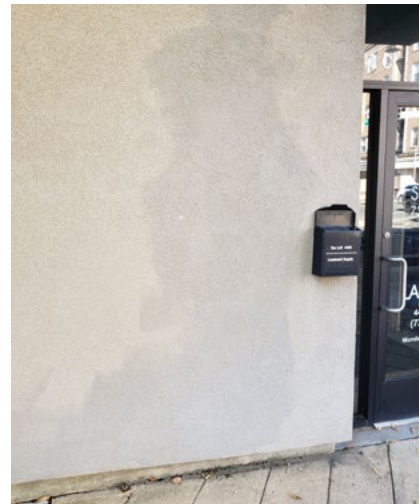
Representative Photos

Block 3002, Lot 7 is a rectangular-shaped corner lot with 50 feet of frontage along the south side of Raritan Avenue and 100 feet of frontage along the west side of South 5th Avenue, and is approximately 5,000 square feet (0.1148 acres) in area. The property conforms to the bulk requirements of the zoning ordinance; however, the building is non-conforming with the rear yard setback, lot and impervious coverage requirements, and potentially other ordinance standards.

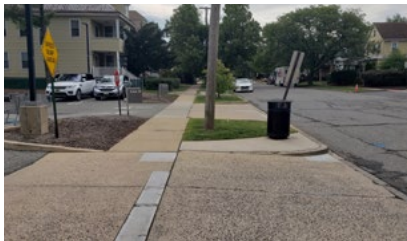
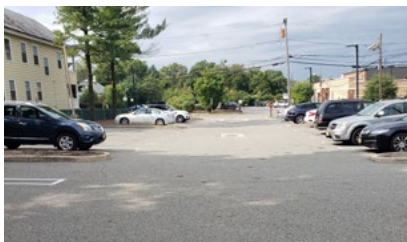
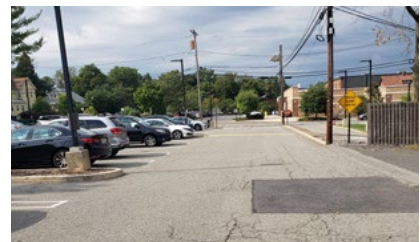
Representative Photos

Block 3002, Lots 34 & 36 and Lot 35, taken together, is an irregularly-shaped mid-block lot with 78 feet of frontage along the east side of South 4th Avenue, approximately 136 feet of frontage along the south side and approximately 22 feet of frontage along the east side of the stub public right-of-way, and is approximately 13,230 square feet (0.3037 acres) in area. The two (2) properties, taken together, conform to the bulk requirements of the zoning ordinance;
